Applying Infrared Imaging Techniques to Marine Surveying

John (JACK) N. Allinson
J.N. Allinson Associates, Inc.

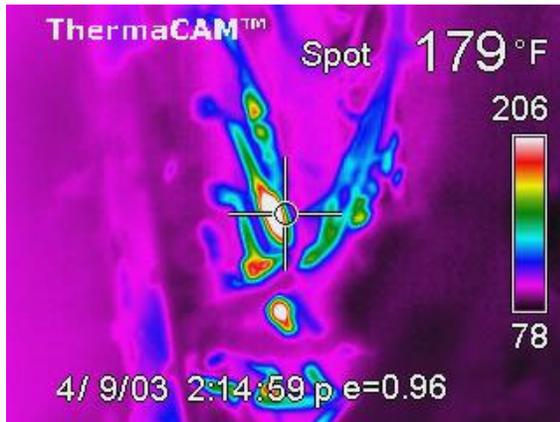
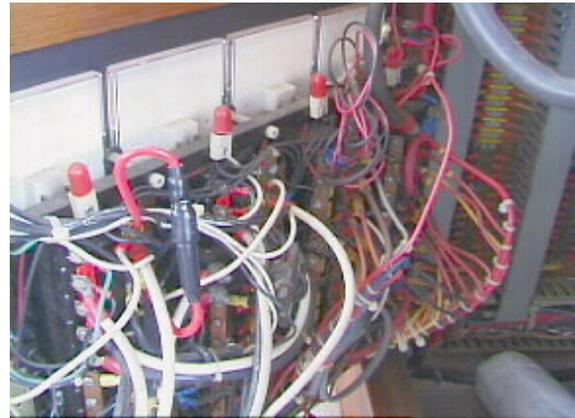
Figure 1. This is the back of an electric distribution panel in a 40-foot boat. Visual inspection shows that the wires are intact, wire insulation and terminals were free of burn or scorch marks. Infrared view shows that one of the wires in the bundle of wires is much hotter than the others. The heat and resistance in this wire caused its magnetic circuit breaker to trip intermittently.

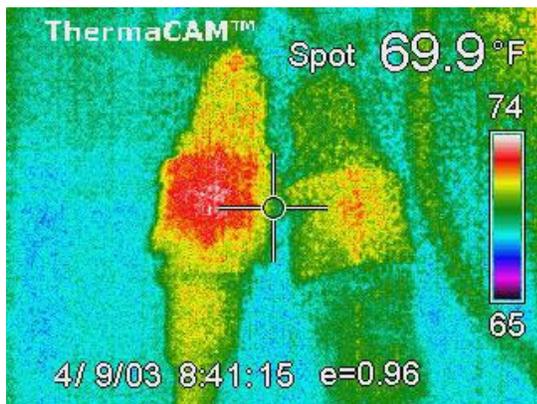
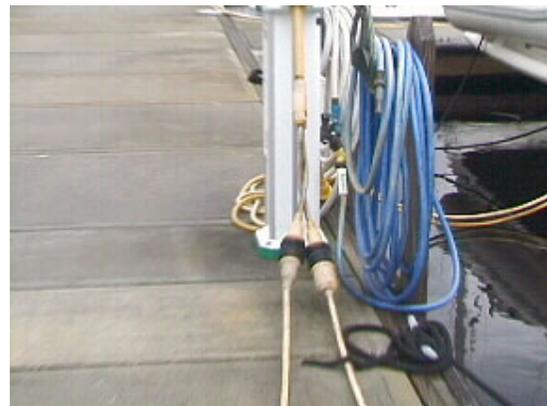
Figure 2. This is a power pedestal on a dock that supplies electric power (shore power) to a boat. A single 50 amp 220vAC shore power cord (light yellow) splits into two (2) 30 amp 110 VAC feeds. This item is known as a “Y adapter” and commonly used for boats that have two (2) 30 amp 120 VAC inlets. There is electrical resistance building up on the left leg of the “Y adapter” and it should be scheduled to be replaced.

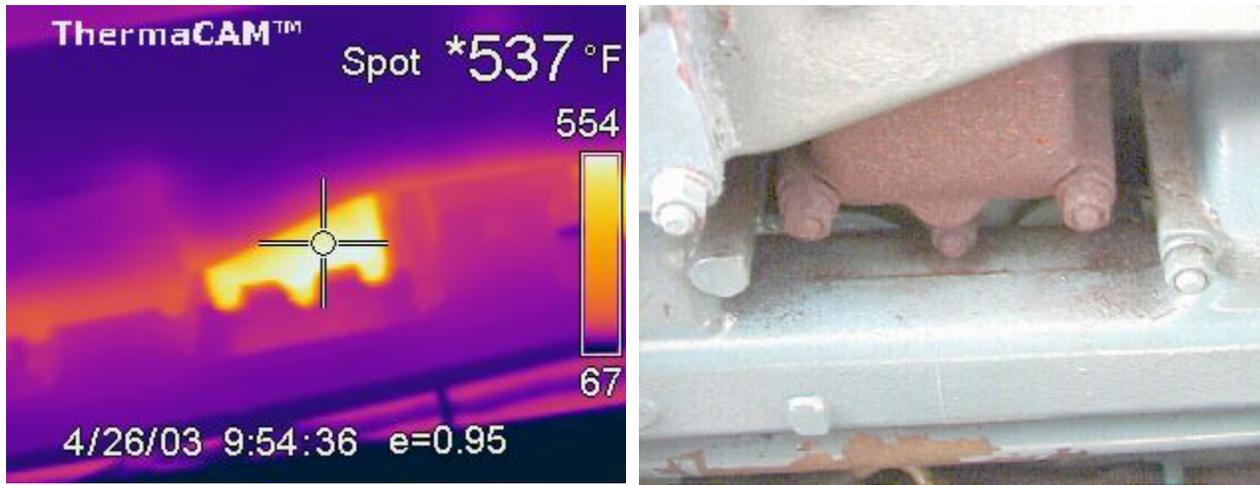
Figure 3. Views of a portion of an exhaust manifold for a 160 hp 6 cylinder turbocharged diesel engine. During the sea trial, the engine overheated. A thermal image of one of the exhaust ports on the manifold showed excessive temperature. Buyer advised to have a marine mechanic examine the turbocharger system.

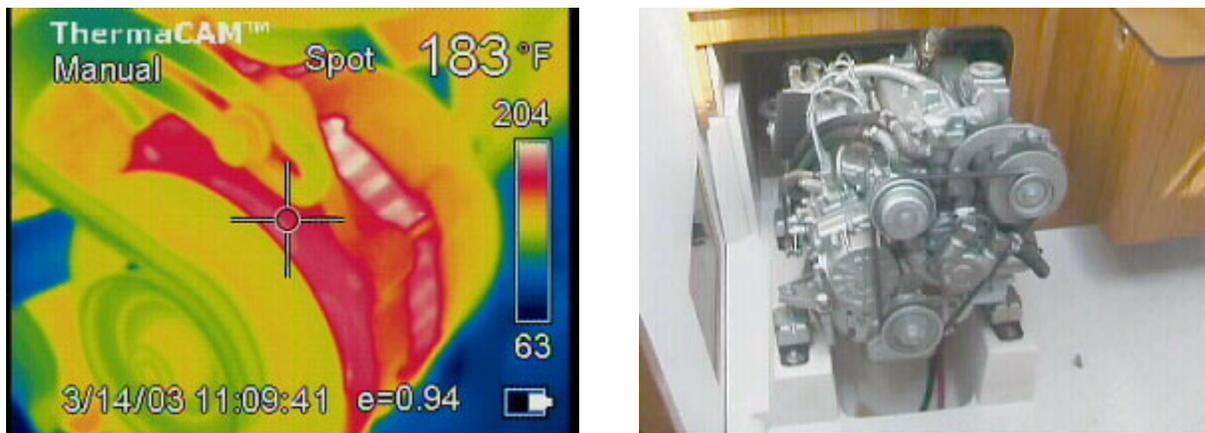
Figure 4. Views of a 3-cylinder naturally aspirating diesel engine. Visual photograph (right) shows the engine with a factory installed low amperage output 12VDC alternator. Owner replaced original “wet cell” battery bank to one with a larger capacity. The new battery bank was much too large to be effectively charged by the factory installed alternator. There were no visual signs that the alternator was being overworked, however the battery bank would never get fully charged and batteries suffered from sulfation. Infrared showed windings in alternator were hotter than expected. This visual evidence coupled with measuring low input voltage at the battery terminals solidified the recommendation why the buyer should upgrade to a higher amperage output alternator.

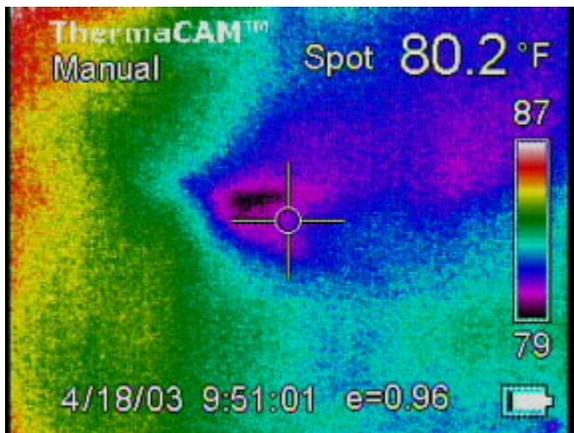
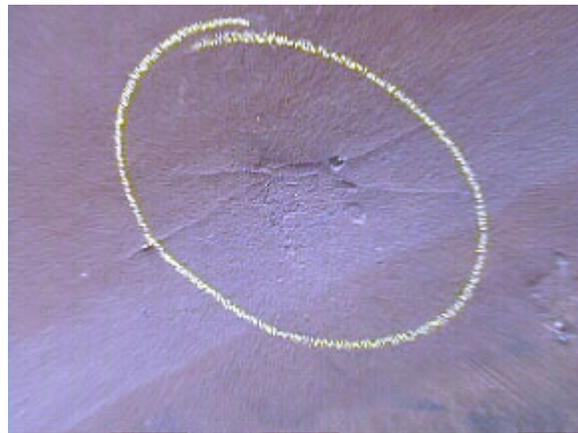
Figure 5. The area circled in yellow shows an unusual indentation in the hull of a boat constructed with FRP. Area visually appears dry. Infrared image shows cooler temperature, revealing moisture intrusion in this portion of the hull.

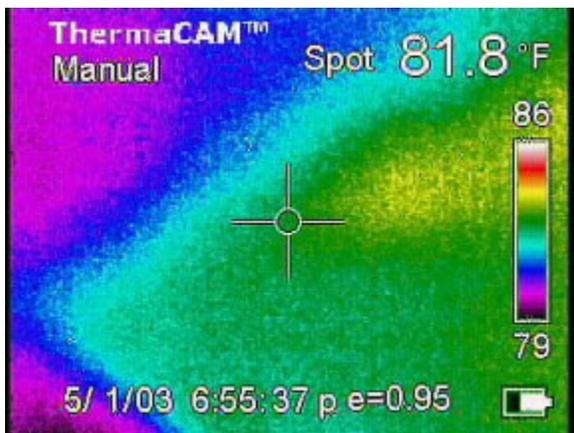
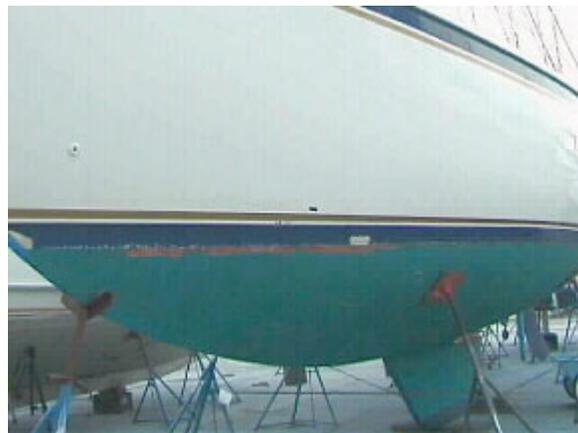
Figure 6. This is the side of a sailboat constructed with FRP. The sailboat sustained impact damage and there was a faint visual sign of delamination. The infrared image shows warmer temperatures, revealing the extent and pattern of delamination in the FRP.

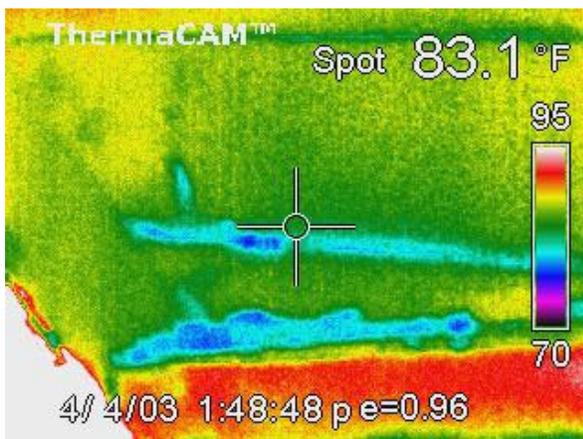
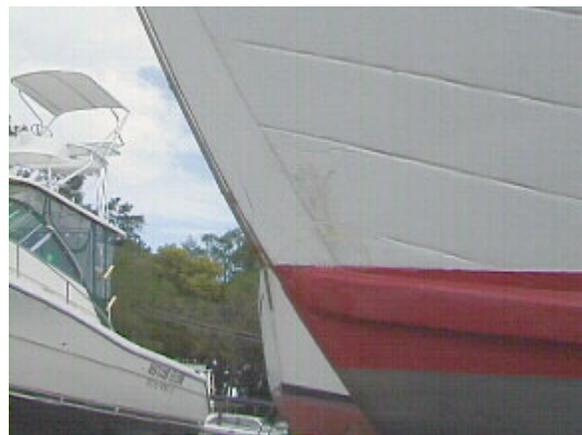
Figure 7. Views of the bow of a boat hull constructed of wooden planks. Routine maintenance involves caulking the seams between the wooden planks to prevent moisture intrusion. The infrared image confirms that caulking is needed as it shows cooler areas where moisture has entered into seams.

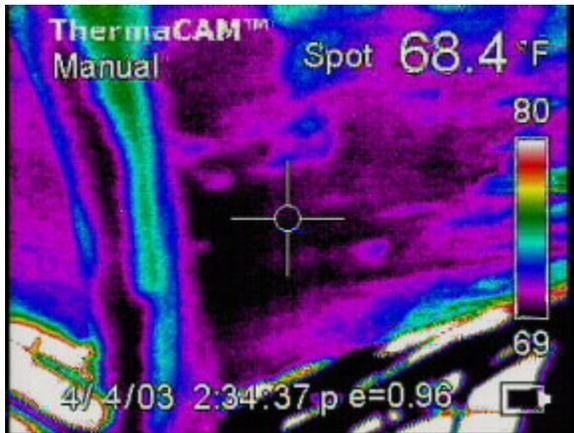
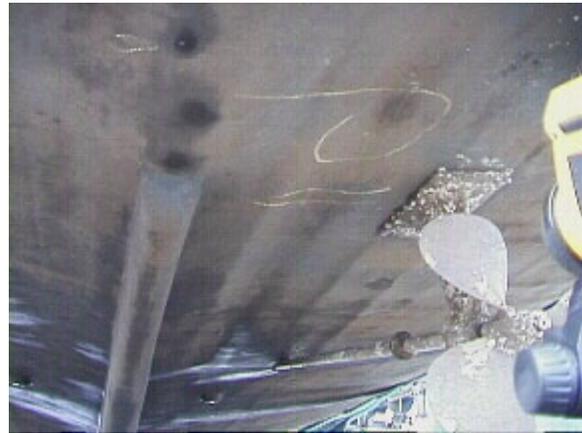
Figure 8. A common practice to extend the life of the bottom of a wooden boat is to sheath it in FRP. It is used to reduce maintenance and prevent marine organisms (e.g., Terado worms) from boring into the wood. Sometimes the physical bond between the wood and FRP breaks down, and water gets trapped in the interstitial space. The wood continues to decay and the FRP disbonds from the wood. Coolness in the infrared image shows the extent of water entrapment and disbonding that can be heard when sounding the hull with a percussion hammer.

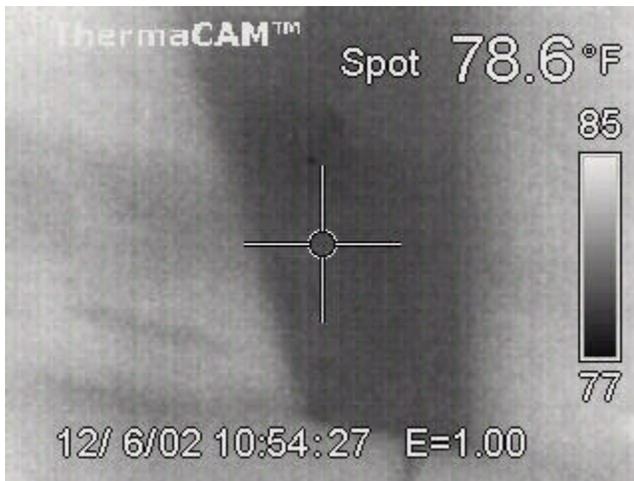
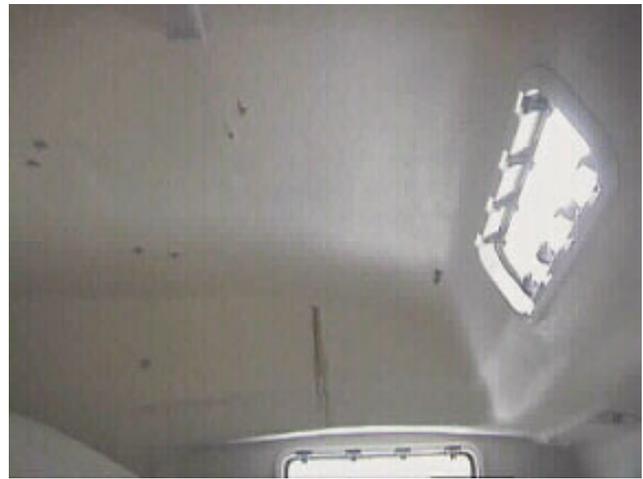
Figure 9. This is the interior ceiling of a FRP constructed catamaran sailboat. Brown fluid observed running out down the ceiling wall visually shows there is a problem with water intrusion. The ceiling is a sandwich construction composite of an outer skin of FRP, an intermediate core of wood, and an inner skin of FRP. The black and white pallet infrared image (left) shows the extent of moisture intrusion.

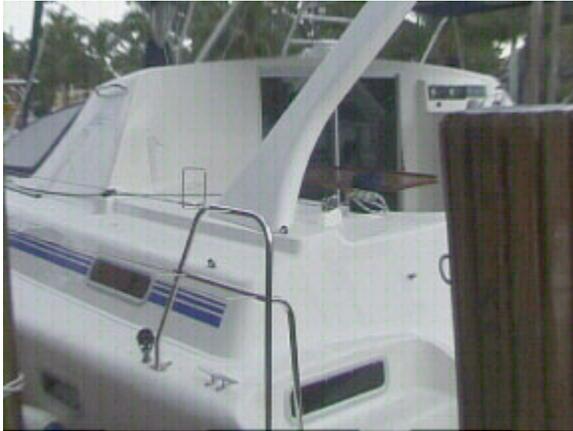
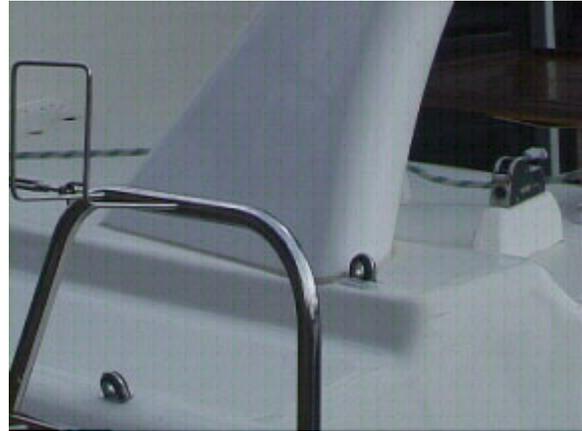
Figure 10. On deck photos of the sailing catamaran shows the exterior side corresponding to the interior ceiling. Note the raised deck in the FRP construction. It is common practice to use a composite construction to reduce the weight of the boat. In this case the composite is FRP/wood/FRP. If the raised deck area were constructed with a solid FRP laminate, it would be much heavier and cost more to construct. A lighter boat sails faster than a heavier boat.
