The Use of Infrared Thermal Imaging in Indoor Environmental Investigations

Mary A. Finn,
The Finn Group

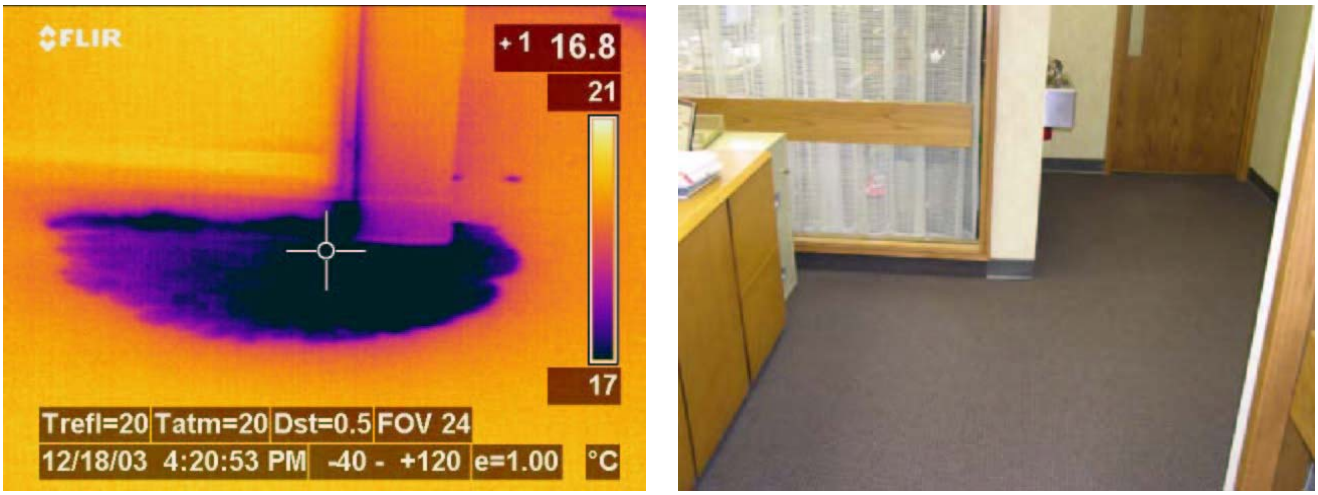
Figure 1 is the IR image and photo showing water intrusion into the wall and carpeting from a plumbing leak within the wall cavity.

Figure 1. Thermogram/photo showing water intrusion from plumbing leak inside wall behind fountain

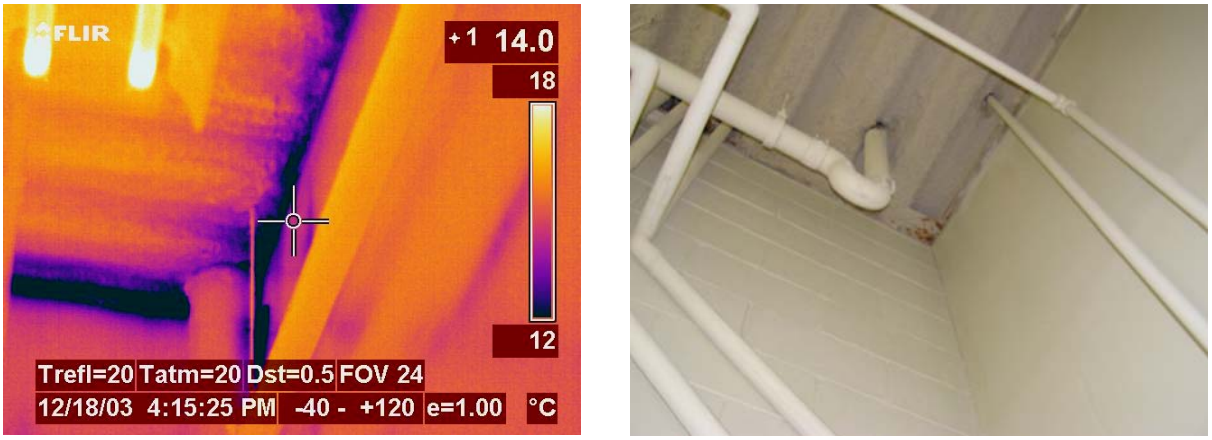
Figure 2 is the IR image and photo showing water intrusion into the basement that was obscured by the fireproofing. Failures in the sealant in the sill plate were identified that were resulting in the entrance of water and uncontrolled air into the building.

Figure 2. Thermogram/photo showing water intrusion into basement due to failure in sealant of sill plate

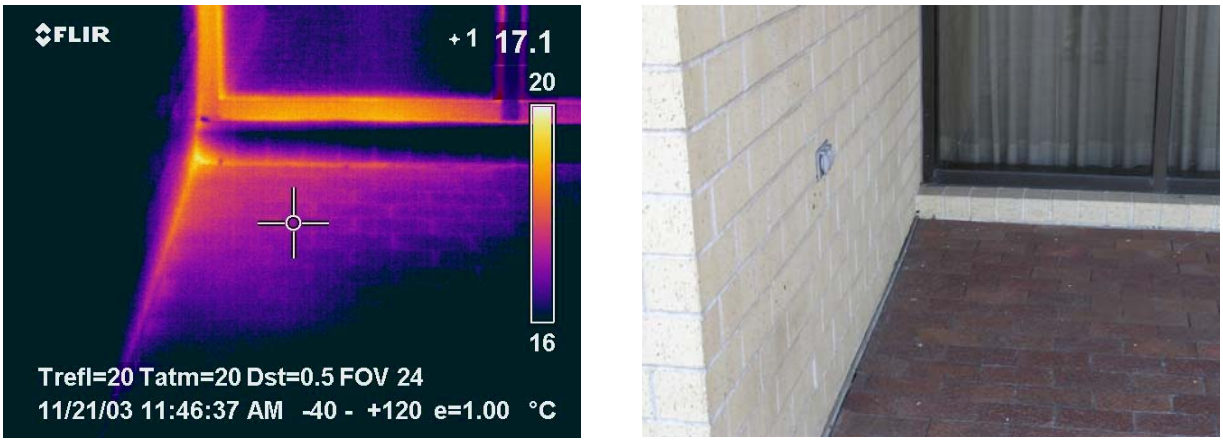
Figure 3 is the IR image and photo from the grade level of the exterior of the building. Failures in the sealant were identified through the IR pattern of heat loss from indoors. The air pressure inside the building was negative, and this failure was an entry point for uncontrolled air.

Figure 3. Thermogram/photo showing loss of heat from inside building due to failure in sealant

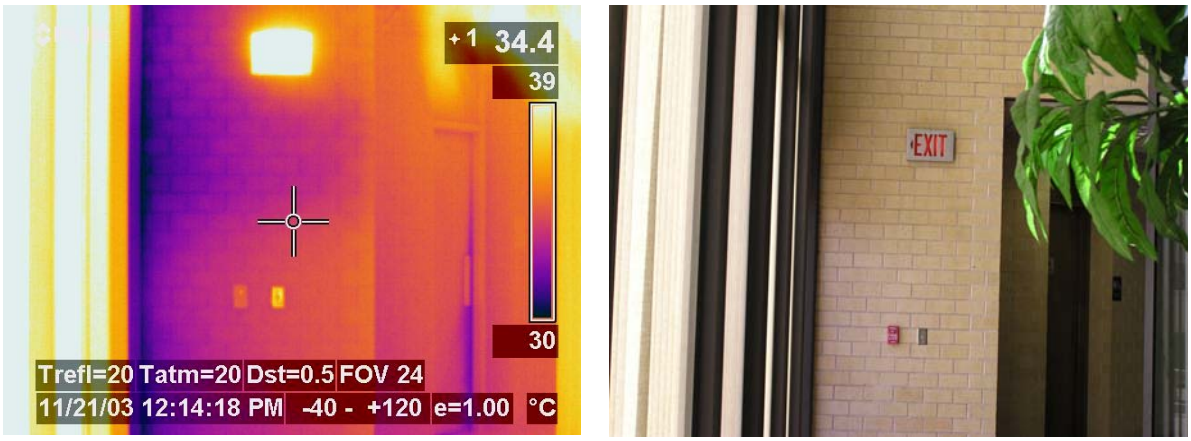
Figures 4 and 5 are the IR images and photos showing the entrance of uncontrolled cold air due to the unbalanced operation of the HVAC system, which resulted in a negative air pressure inside the building with respect to outdoors.

Figure 4. Thermogram/photo showing entrance of uncontrolled cold air due to negative air pressure inside building from unbalanced operation of HVAC system

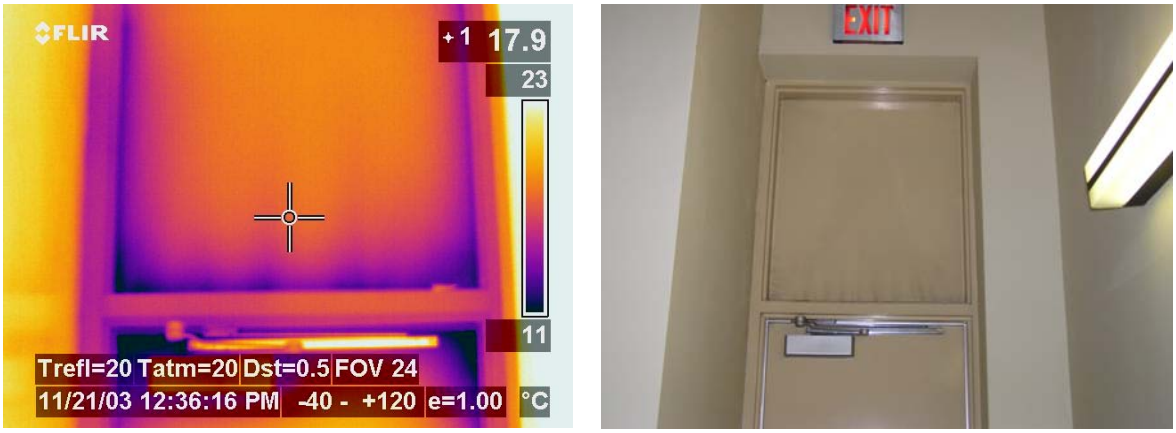
Figure 5. Thermogram/photo showing entrance of uncontrolled cold air due to negative air pressure inside building from unbalanced operation of HVAC system.

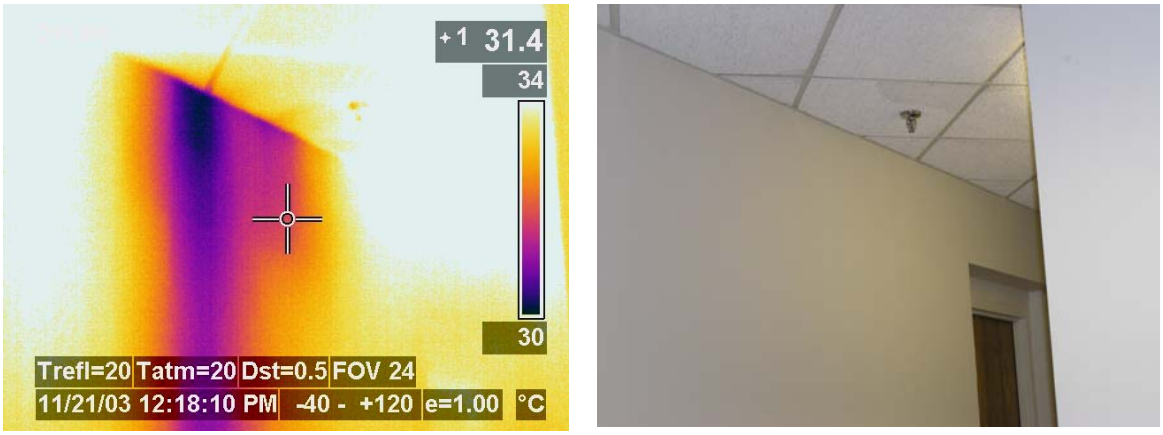
Figure 6 is the IR image and photo showing temperature differentials resulting from cooler air from the plenum space entering the occupied space. This indicates that the plenum space is under positive pressure with respect to the occupied space due to the unbalanced operation of the HVAC system.

Figure 6. Thermogram/photo showing entrance of cooler air from plenum due to positive air pressure in plenum from unbalanced operation of HVAC system

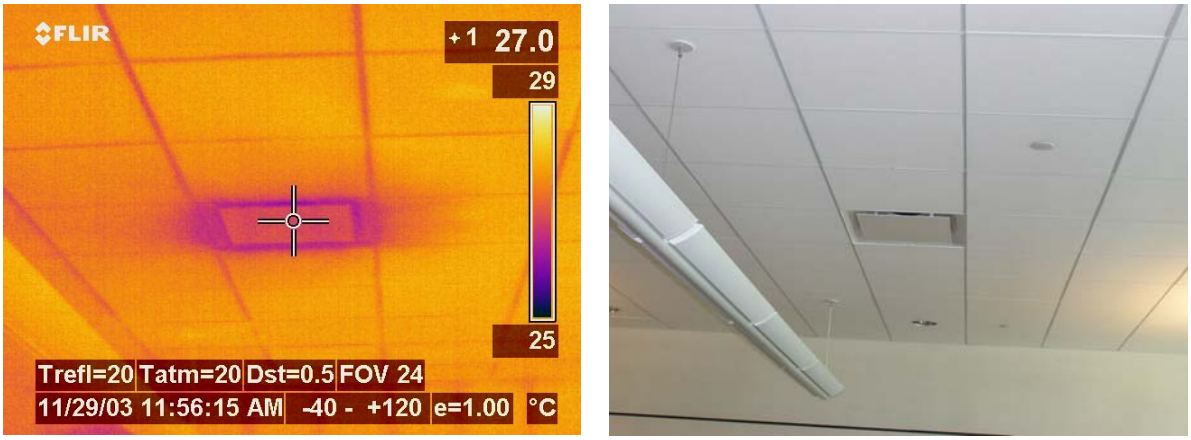
Figure 7. Thermogram/photo showing uniform air distribution pattern from supply register

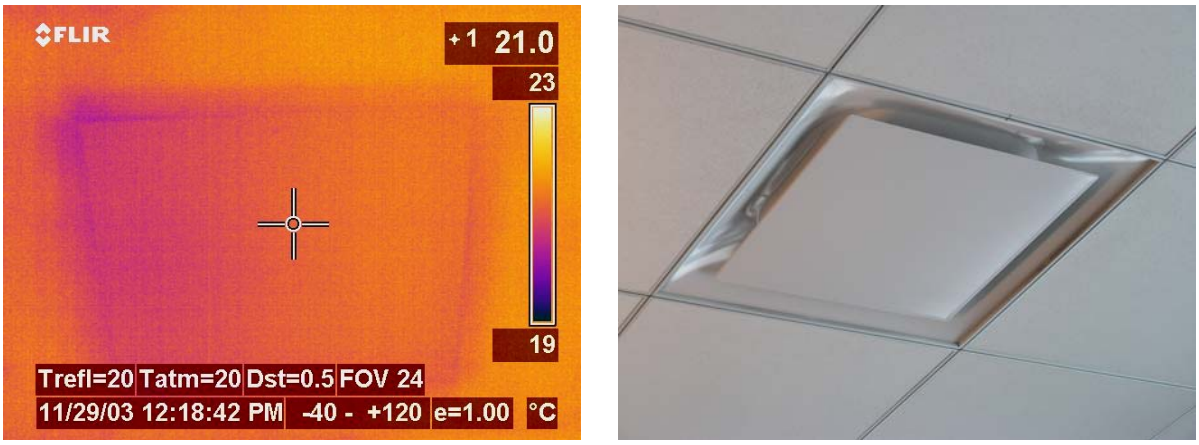
Figure 8. Thermogram/photo showing non-uniform air distribution pattern from supply register

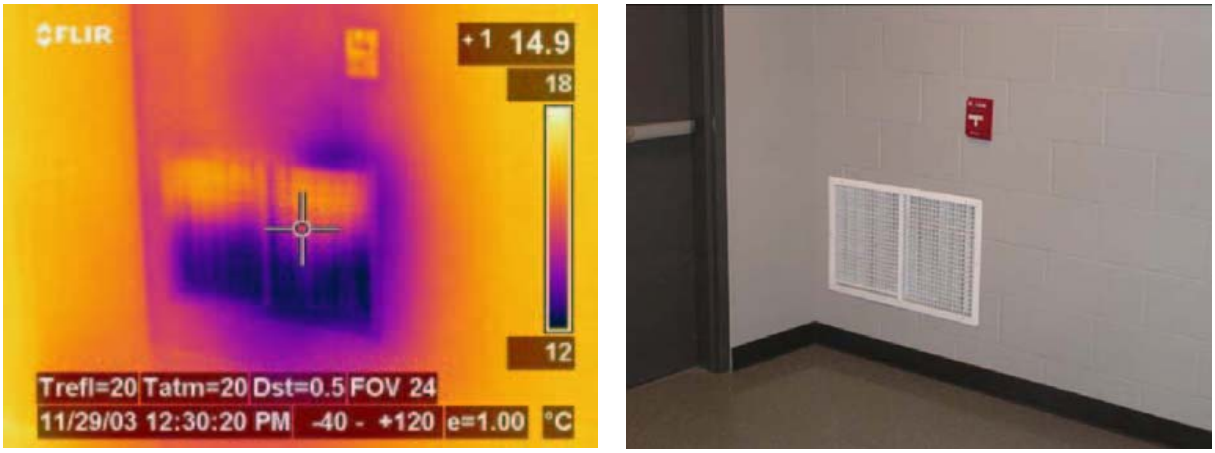
Figure 9. Thermogram/photo showing non-uniform air distribution pattern from supply register
